No. 730

PRACTICAL EXPERIENCES WITH  
LIGHTNING DISCHARGES TO AIRPLANES

By Heinrich Koppe

Zeitschrift für Flugtechnik und Motorluftschiffahrt  
Vol. 24, No. 21, November 4, 1933

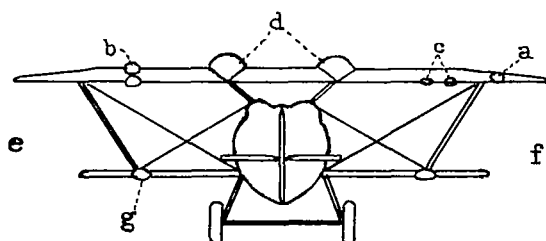
There also is a record of three cases of lightning discharge in airplanes without antenna: two, in wooden airplanes flying through thunderstorm, and one in which lightning hit twice. This particular airplane, a biplane, all wood, (fig. 6) attempted to fly through the front of a thunderstorm. There was first a discharge through the right wings in the clouds, in heavy snowstorm. A few seconds later lightning hit the left wings very severely. The

pilot was almost blinded and felt slightly lame which effects, however, soon disappeared. The remarkable thing is that in both cases the discharge passed through the wings near the wooden struts, and did not follow the fuel line. In another case a twin-engine airplane of the mixed type released a lightning discharge while flying through clouds in a heavy snowstorm. The discharge passed over one of the outboard engines and caused temporary ignition disturbance. The fabric covering of the wings, as well as the ribs and fittings were damaged considerably.

a, 1st. stroke. f, left  
b, 2nd. " g, fusing  
c, traces and  
d, fuel tanks welding  
e, right effect

Figure 6.-Double discharge to "Berline-Spad"; pilot Sladek, Oct. 15, 1925

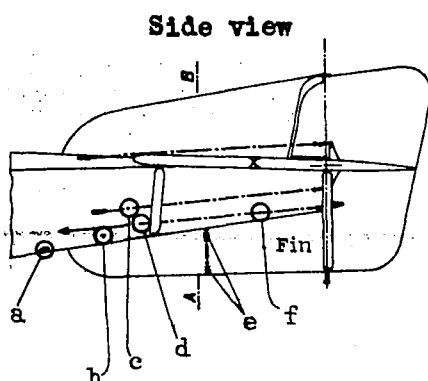
the electric charge must clear the path to better conductors within the airplane, the outer skin is destroyed. Thus wings covered with wood or cloth were damaged when the path led over the antenna egg or over the wires to the position lights. Such damages (fig. 8a,b) may consist of small, round scorched holes in the wood or fabric, although tearing and ripping off of larger pieces is not unknown. Steel is a poor conductor for the lightning current; for which reason lightning does not follow steel cable very often, but so much greater is the danger of fusion by current contacts. For instance, note the burnt 1 mm steel wire fin braces on the wood-fabric airplane (fig. 9).

a, tear due to pressure effect  
b, arc outward, antenna weight  
c, HR-S light trace of fusion  
d, SR-S light trace of fusion  
e, brace wires fused  
f, 3 rudder-cable strands fused

Figure 9.-Damage to a wood-fabric airplane

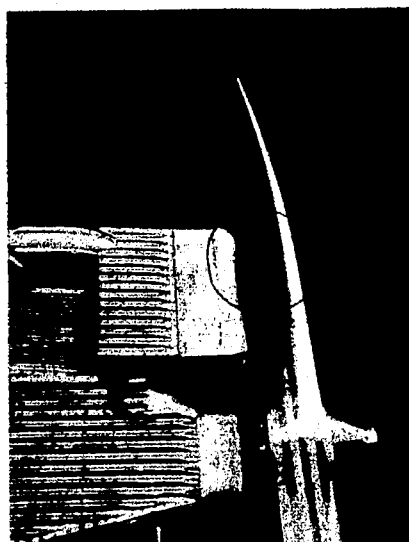
For the same reason the lightning discharge does not follow the engine shaft to the propeller but generally jumps over from the engine, cowl or radiator (fig. 10). That propellers in particular act as equalizers is well known and confirmed by the frequently observed Saint Elmo's fire. This may readily lead to current contacts with pronounced heating from airplane to propeller, but also from propeller to the surrounding, highly ionized air (fig. 11). Hence the traces of fusion on the radiator, cowl and other contact points in all-metal airplanes (fig. 12).

Figure 10. Arc from body to propeller.

The propeller is very frequently damaged, being a particularly strong equalizing structural component. All-metal propellers are more proof against such damages than metal-tipped wood propellers; in any case the tipping should not be too thin and should form a good connection with the engine. This can be insured by shields and copper rings inserted at the hub (fig. 19). It at any rate prevents the dangerous and destructive arcs.

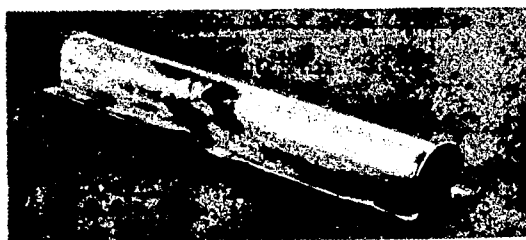
If the lightning follows the antenna into the airplane it generally results in very severe and dangerous damage. Even the all-metal airplane is not immune. When the antenna fairlead forms a convenient direct path to the inside lightning follows it and it merely remains a question of arrangement and design at what point it finds this path inconvenient and tries to find a better one to the engine and the propeller, where it then establishes a contact and usually results in severe and dangerous arcs (fig. 13). This not only produces a fire hazard but it also jeopardizes other vital parts of the airplane (fig. 14).

Figure 14.- Arc on control cable housing.
